DEPARTMENT OF TRANSPORTATION

Contract #: 04-0120F4Cty: SF/ALA Rte: 80 PM: 13.2/13.9File #: 69.28**WELDING INSPECTION REPORT****Resident Engineer:**Siegenthaler, Peter**Address:** 333 Burma Road**City:** Oakland, CA 94607**Report No:** WIR-023059**Date Inspected:** 20-Mar-2011**Project Name:** SAS Superstructure**OSM Arrival Time:** 700**Prime Contractor:** American Bridge/Fluor Enterprises, a JV**OSM Departure Time:** 1900**Contractor:** Zhenhua Port Machinery Company, Ltd (ZPMC), Changxing Island **Location:** Shanghai, China**CWI Name:** Mr. Xu Le Feng.**CWI Present:** Yes No**Inspected CWI report:** Yes No N/A**Rod Oven in Use:** Yes No N/A**Electrode to specification:** Yes No N/A**Weld Procedures Followed:** Yes No N/A**Qualified Welders:** Yes No N/A**Verified Joint Fit-up:** Yes No N/A**Approved Drawings:** Yes No N/A**Approved WPS:** Yes No N/A**Delayed / Cancelled:** Yes No N/A**Bridge No:** 34-0006**Component:** Tower and Orthotropic Box Girder (OBG)**Summary of Items Observed:**

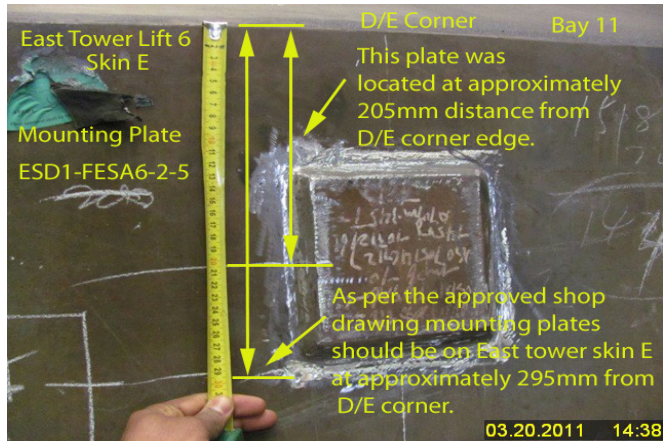
This QA Inspector observed ZPMC qualified welding personnel identified as 202354 Perform Shielded Metal Arc Welding (SMAW) on East Tower lift 6 Skin E. Joint identified as ESD1-FESA6-2-9, 10. ZPMC QC Identified as Mao Bin Bin. The welding parameters as measured using QC's calibrated instrument appeared to be in general compliance with WPS-B-P-2113. For more information see attached picture number 1.

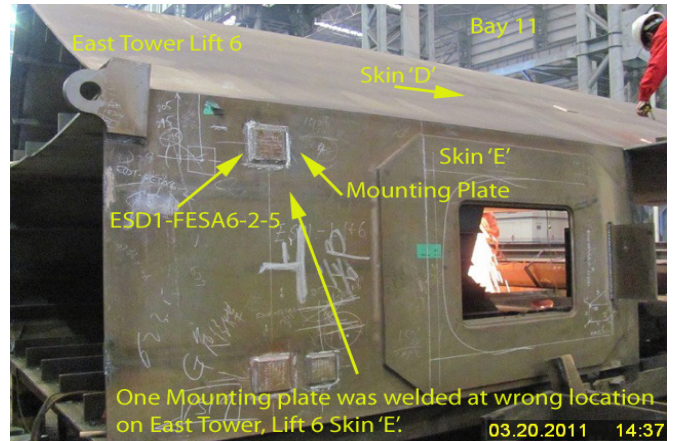
During random visual inspection in Bay 11, this Quality Assurance Inspector (QA) discovered the following issue: One (1) mounting plate was welded at wrong locations on East Tower, Lift 6 Skin 'E'. As per the approved shop drawing mounting plates should be on East tower skin E at approximately 295 mm from D/E corner. This plate was located at approximately 205mm distance from D/E corner edge. The fillet weld identified as

ESD1-EFSA6-2-5. The member is located in Bay#11. For further information, please see the attached pictures:
This QA Inspector generated incident report for this date.
